Materials Solutions for Hydrogen Delivery in Pipelines

Secat, Inc.

2011 U.S. DOE Hydrogen Program Annual
Merit Review and Peer Evaluation Meeting
Arlington, VA

Project ID – PD047

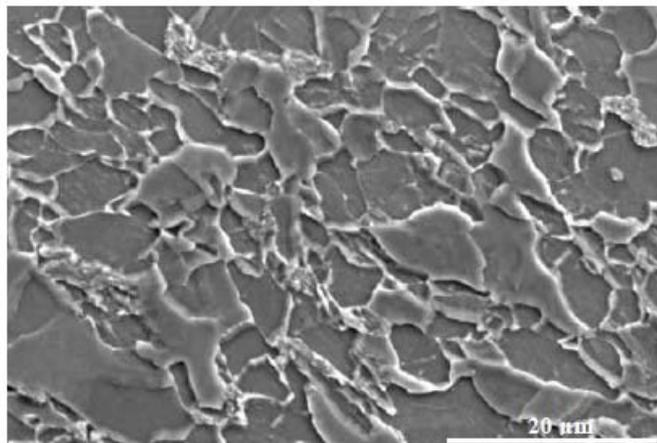
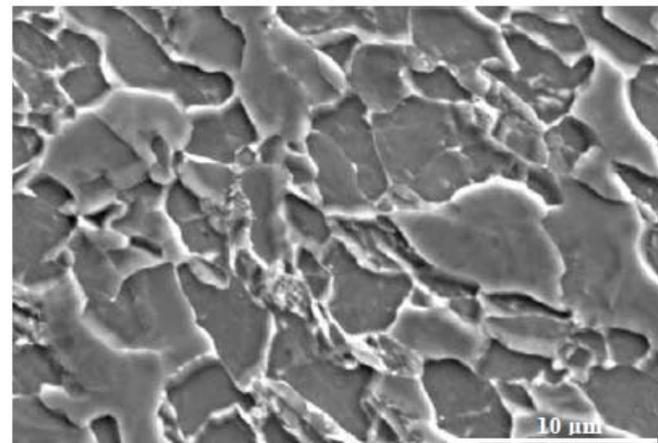
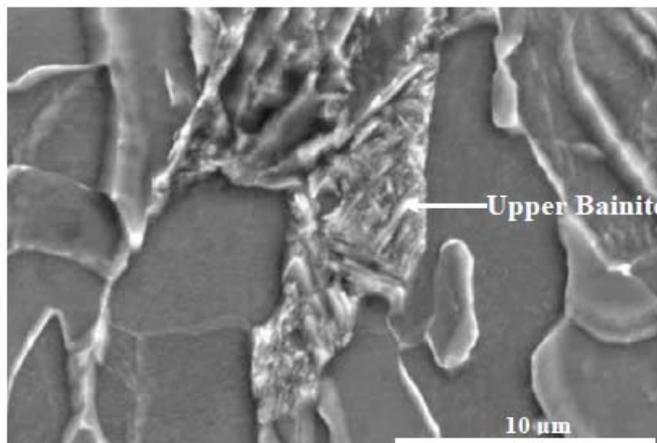
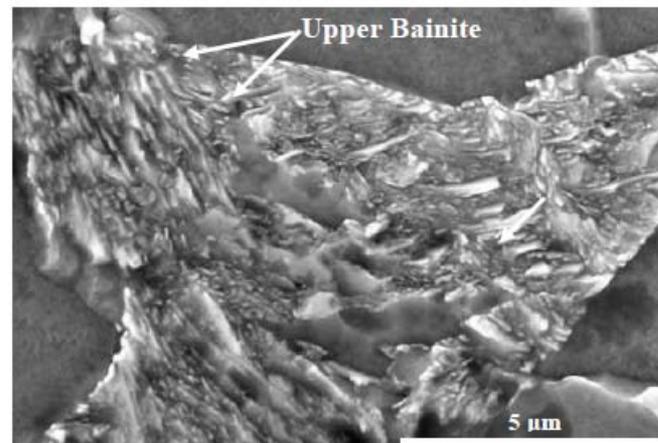
Alloy A (X70) – Polygonal Ferrite/Upper Bainite (Upper Bainite ~ 8%)
SEM Analysis

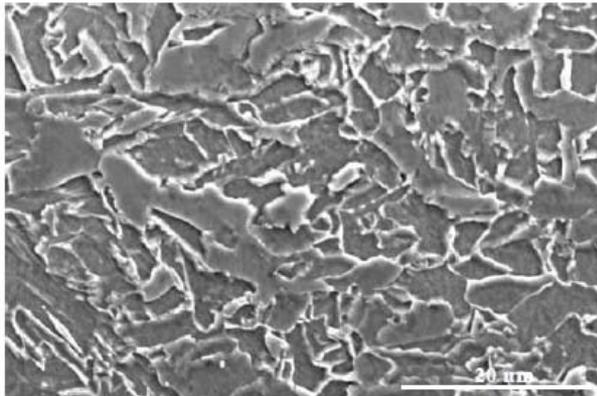
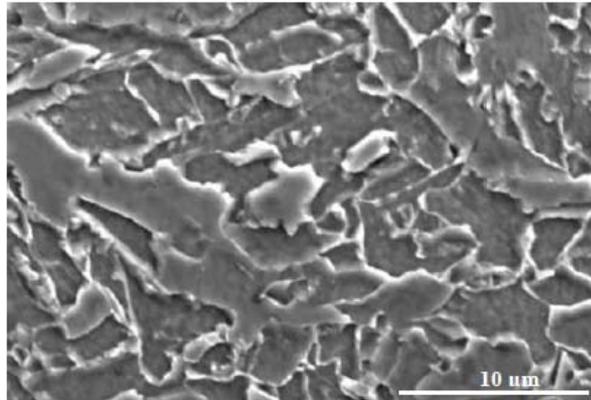
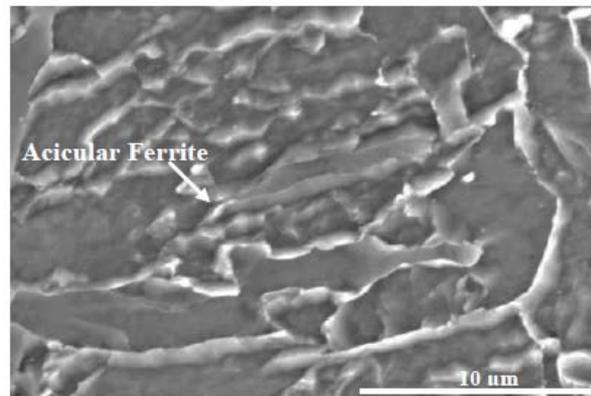
Alloy B (X70/X80) – Polygonal Ferrite/Coarse Acicular Ferrite (type of Bainite) ~ 10%, SEM Analysis

Coarse Acicular Ferrite is more apparent in TEM micrographs

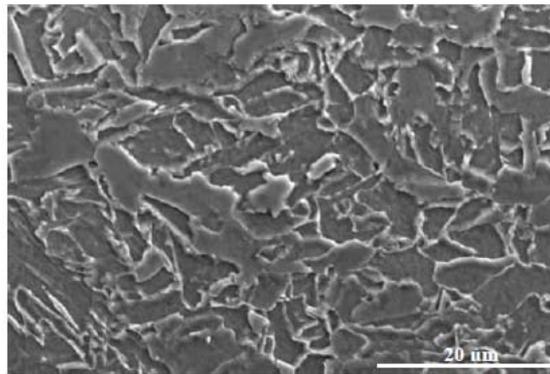
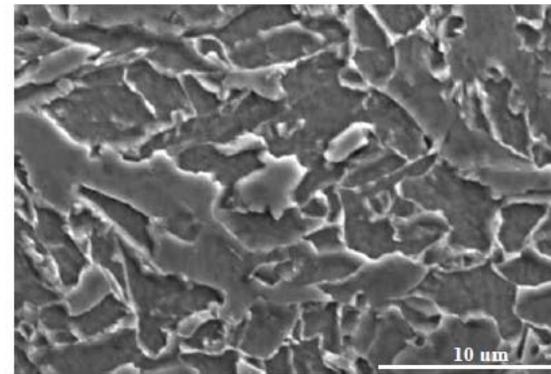
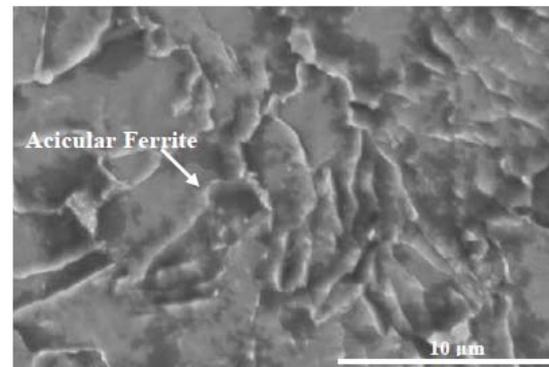
Alloy C (X70/X80) – Polygonal Ferrite/Coarse Acicular Ferrite (type of Bainite), plus Upper Bainite ~ 10%, SEM Analysis

Coarse Acicular Ferrite is more apparent in TEM micrographs

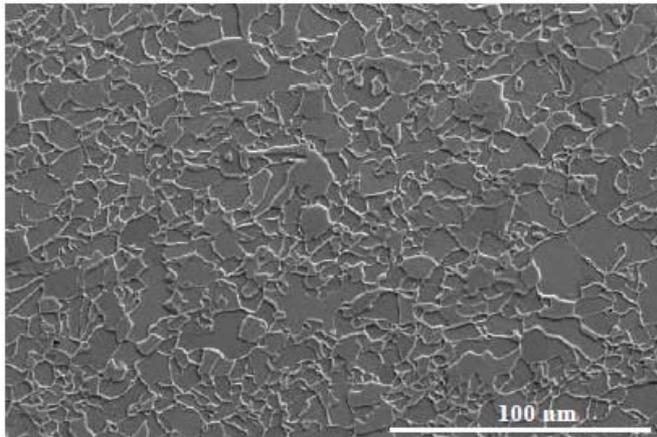
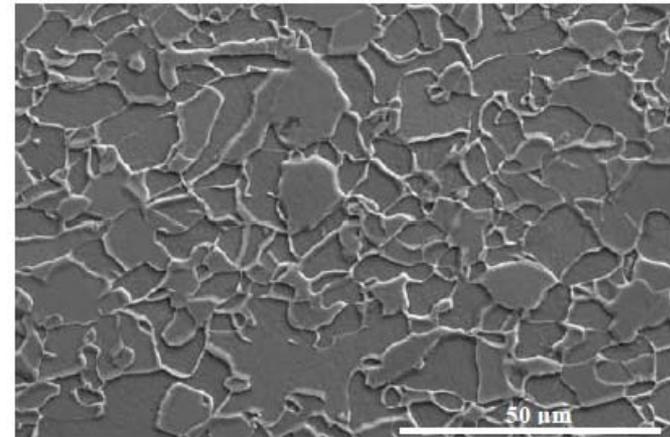
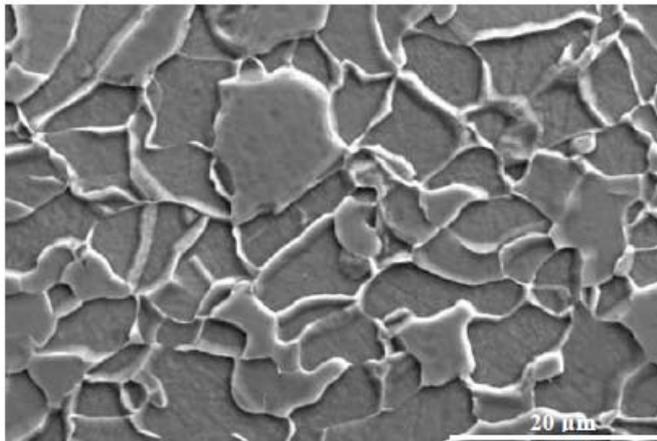
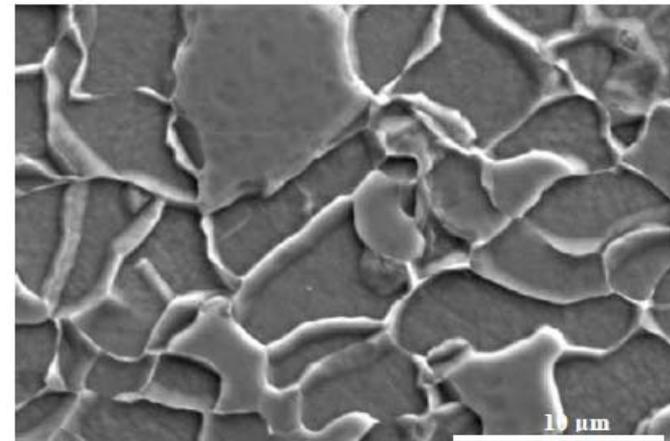
Alloy D (X52/X60 HIC) – Polygonal Ferrite – 100%

SEM Analysis

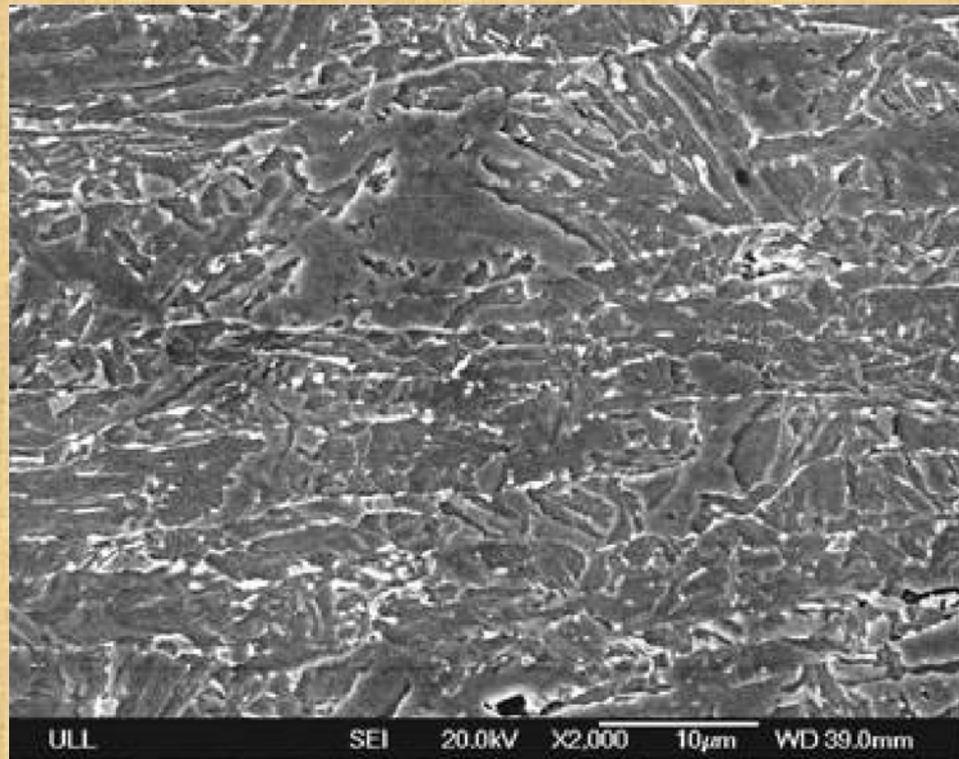
Alloy E (Low C, Abrasion Resistant Steel) – Fine Acicular Ferrite – 100%. SEM Analysis

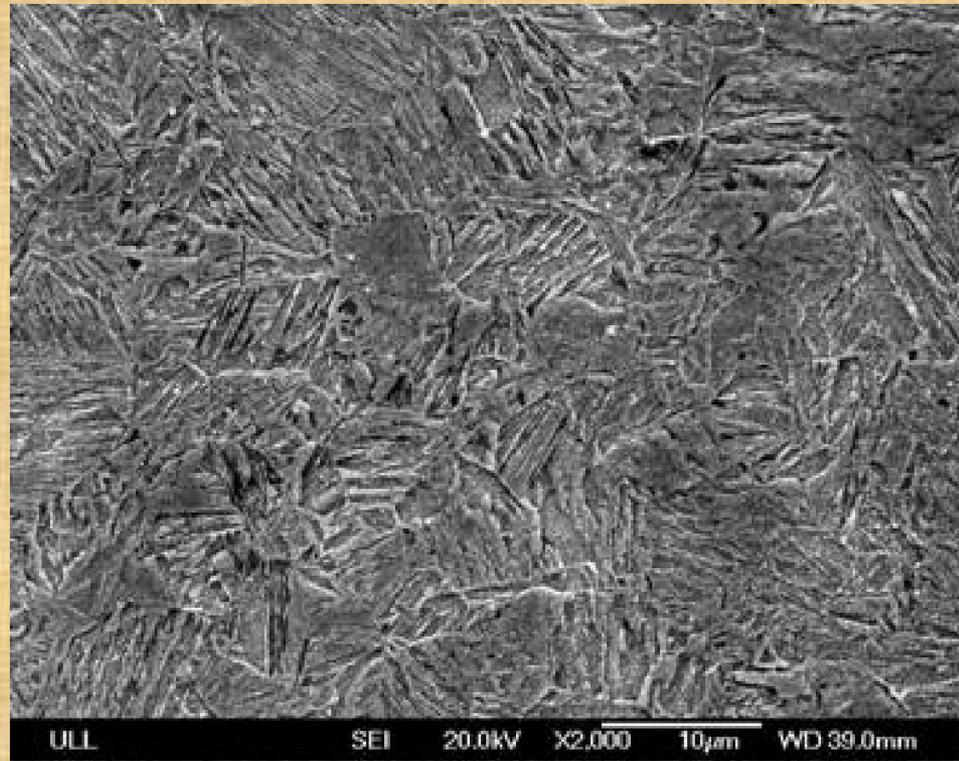
Alloy F (Med C – Hi Alloy, Structural Steel) – Acicular Ferrite – 80%, Lath Type Bainite 20%. SEM Analysis

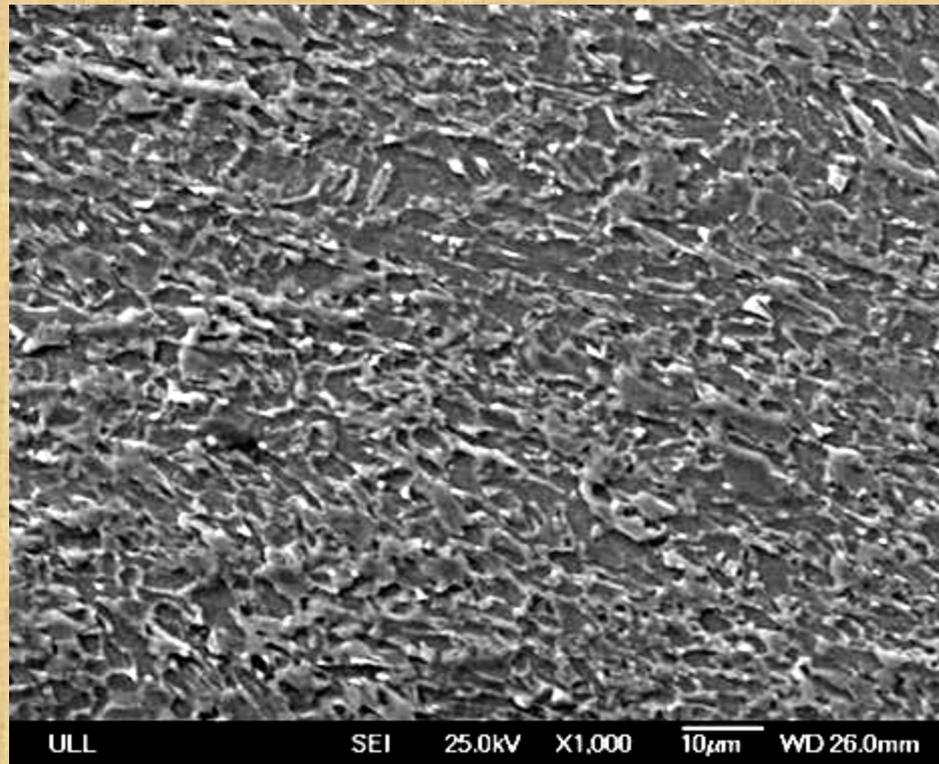
Alloy E (Pipeline Steel) – Fine Acicular Ferrite – 100%. SEM Analysis

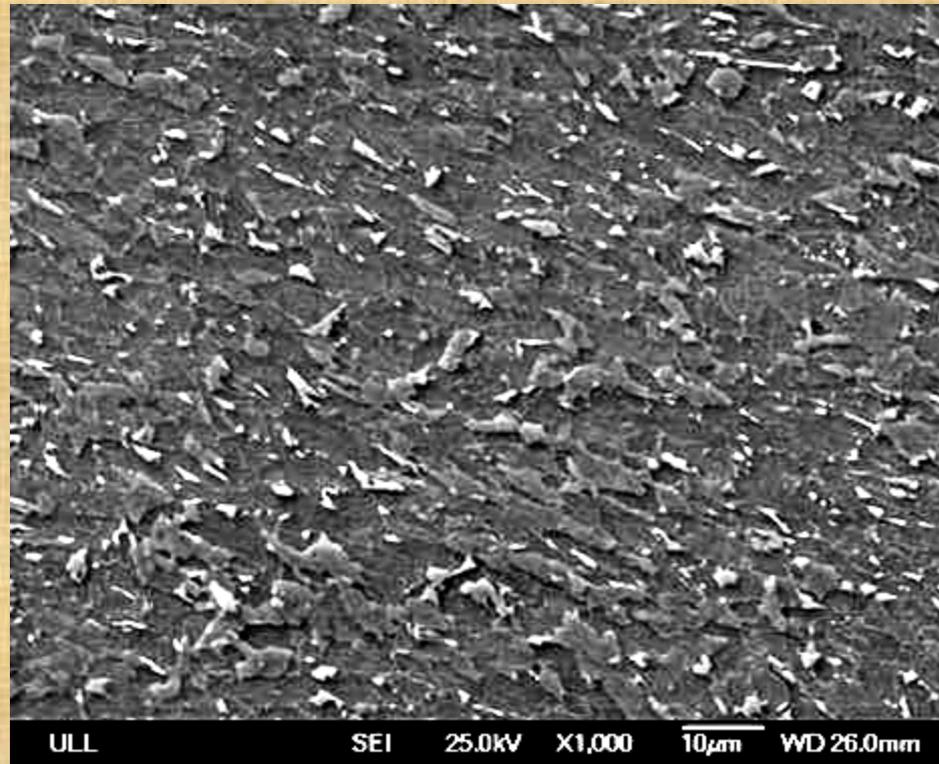
Alloy F (Pipeline Steel) – Fine Acicular Ferrite – 70%, Polygonal Ferrite – 30%. SEM Analysis

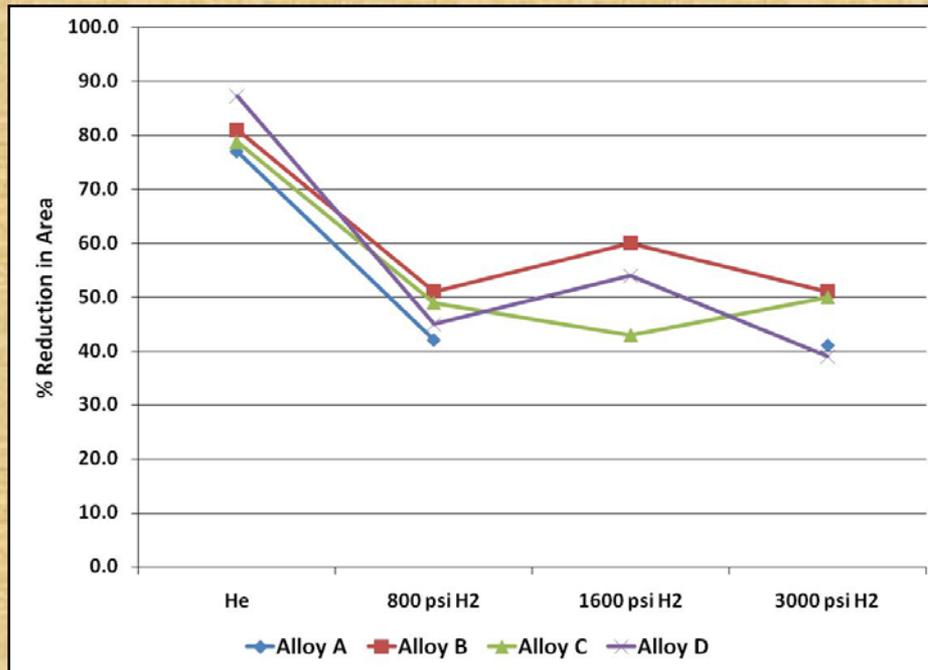
Technical Accomplishments – *In-situ* Tensile Testing Results in Gaseous Helium and Hydrogen

Reduction in Area, 10^{-4}

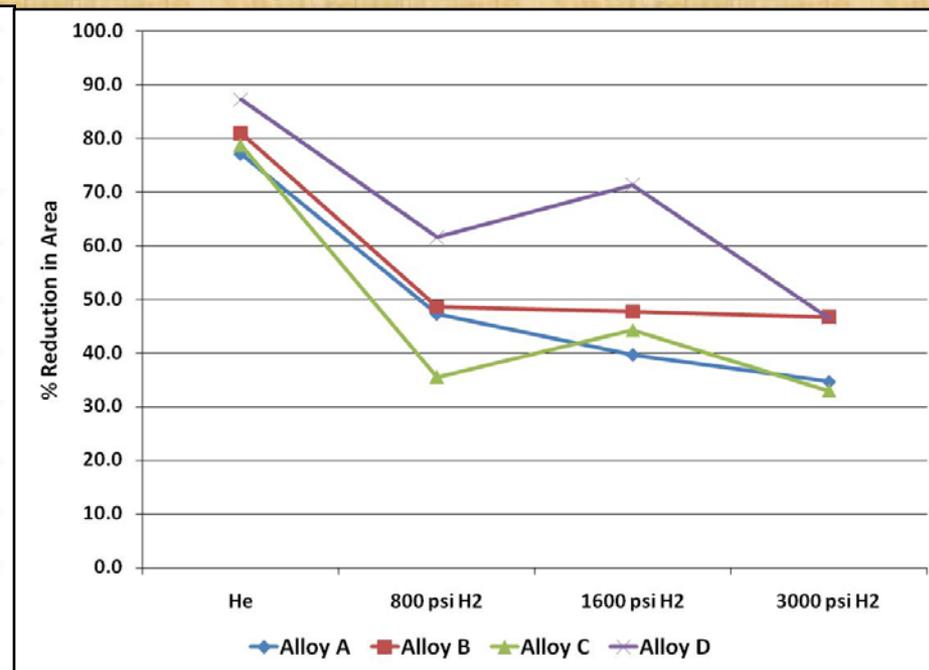
Reduction in Area, 10^{-5}

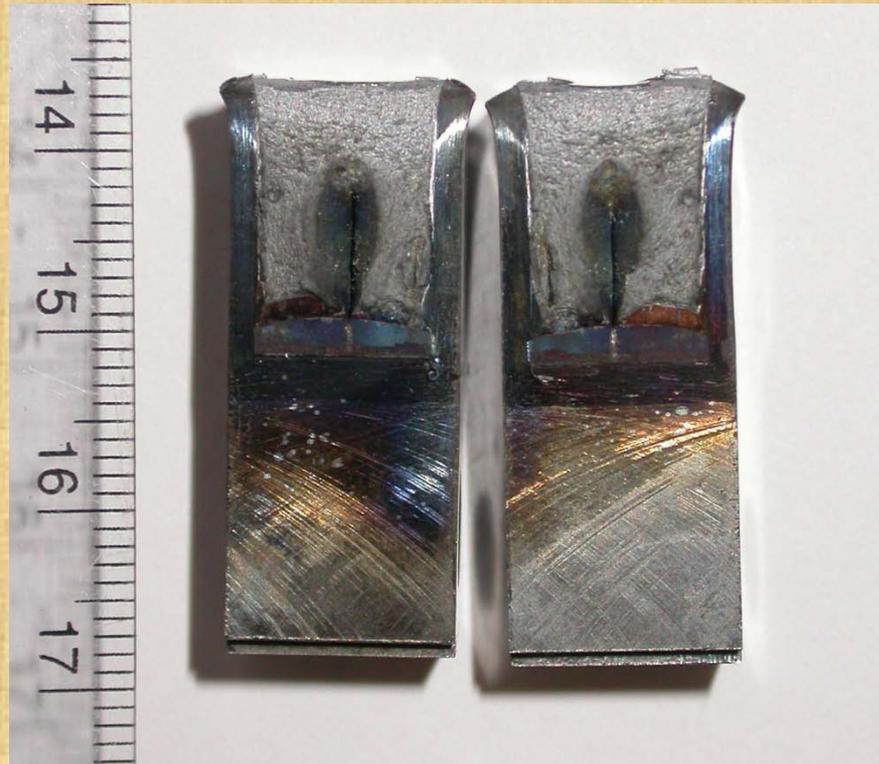
Technical Accomplishments - Fracture Toughness Test Results – Pipeline Alloy A (Private Funded), 3000 psi

•Note large separation/delamination in Alloy A fracture. Maybe related to microstructural banding of chemically segregated centerline. This needs to be understood better as to cause and it's effect on test results. Alloy A fracture toughness results are not yet complete on this sample.

- Increasing pressure appears to decrease resistance to hydrogen effect. There maybe a potential threshold pressure for a given microstructure.
- Separations/delaminations that occur in some of the testing may bias the results. Detailed examination is required to understand the presence of these vs. microstructural characteristics. ***This is an important point to follow up on in future hydrogen work beyond the scope of this project.***

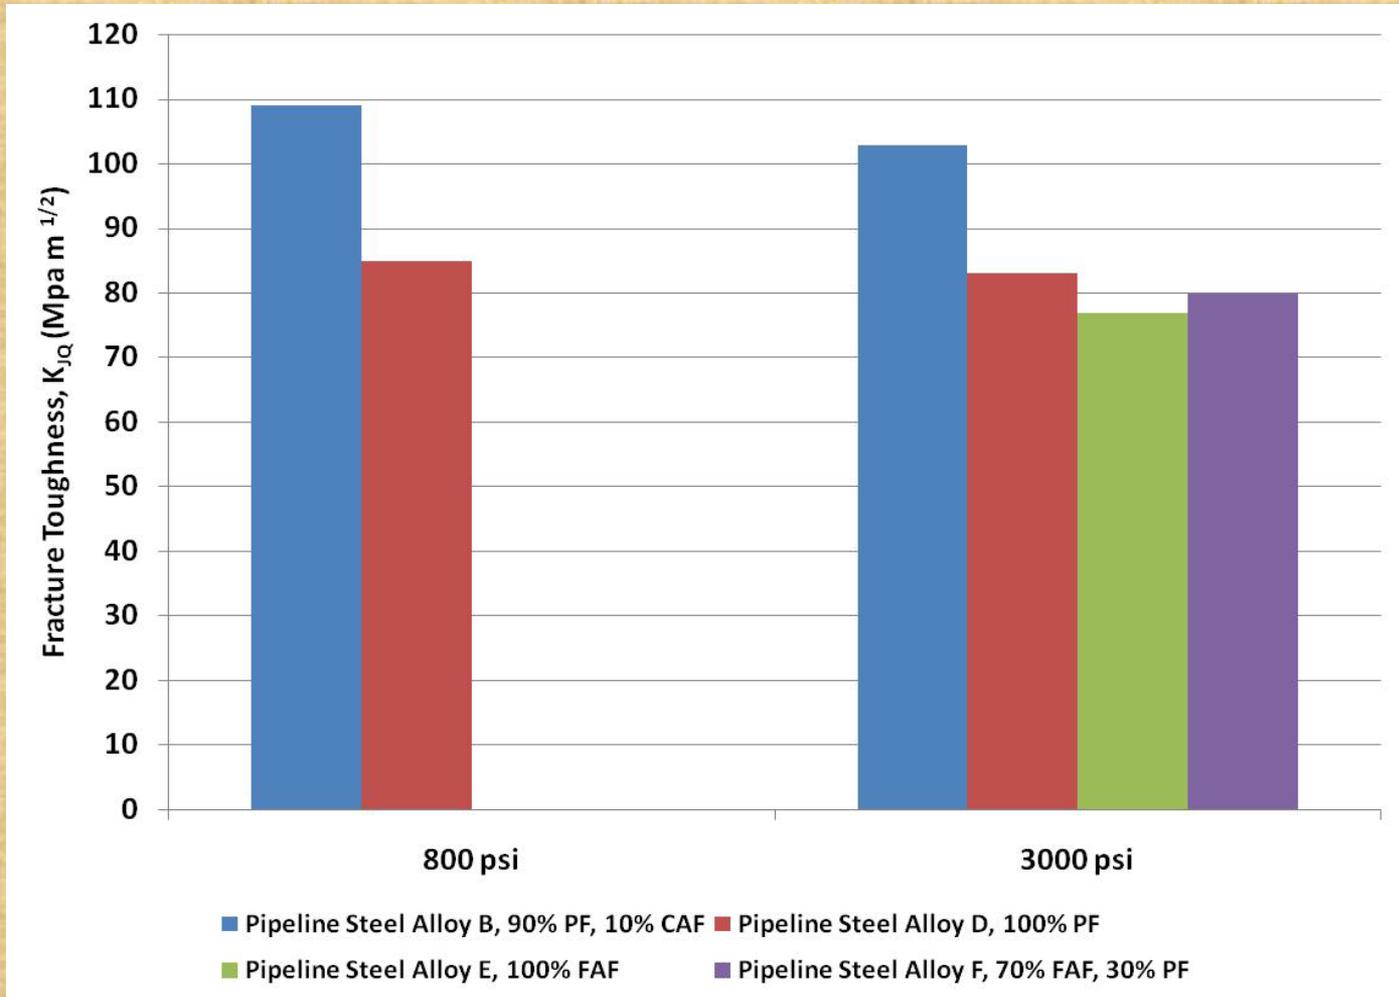
Technical Accomplishments - Fracture Toughness Test Results – Pipeline Steel Alloy’s B, D, E (Private Funded), and F (Private Funded) K_{JIC} vs. Pressure, Average Values

- Increasing yield strength **does not** appear to necessarily result in decreased fracture toughness due to the effect of hydrogen in the 800-3000 psi pressure range tested. Microstructure dependent. This may be different than what others have reported at higher pressures.

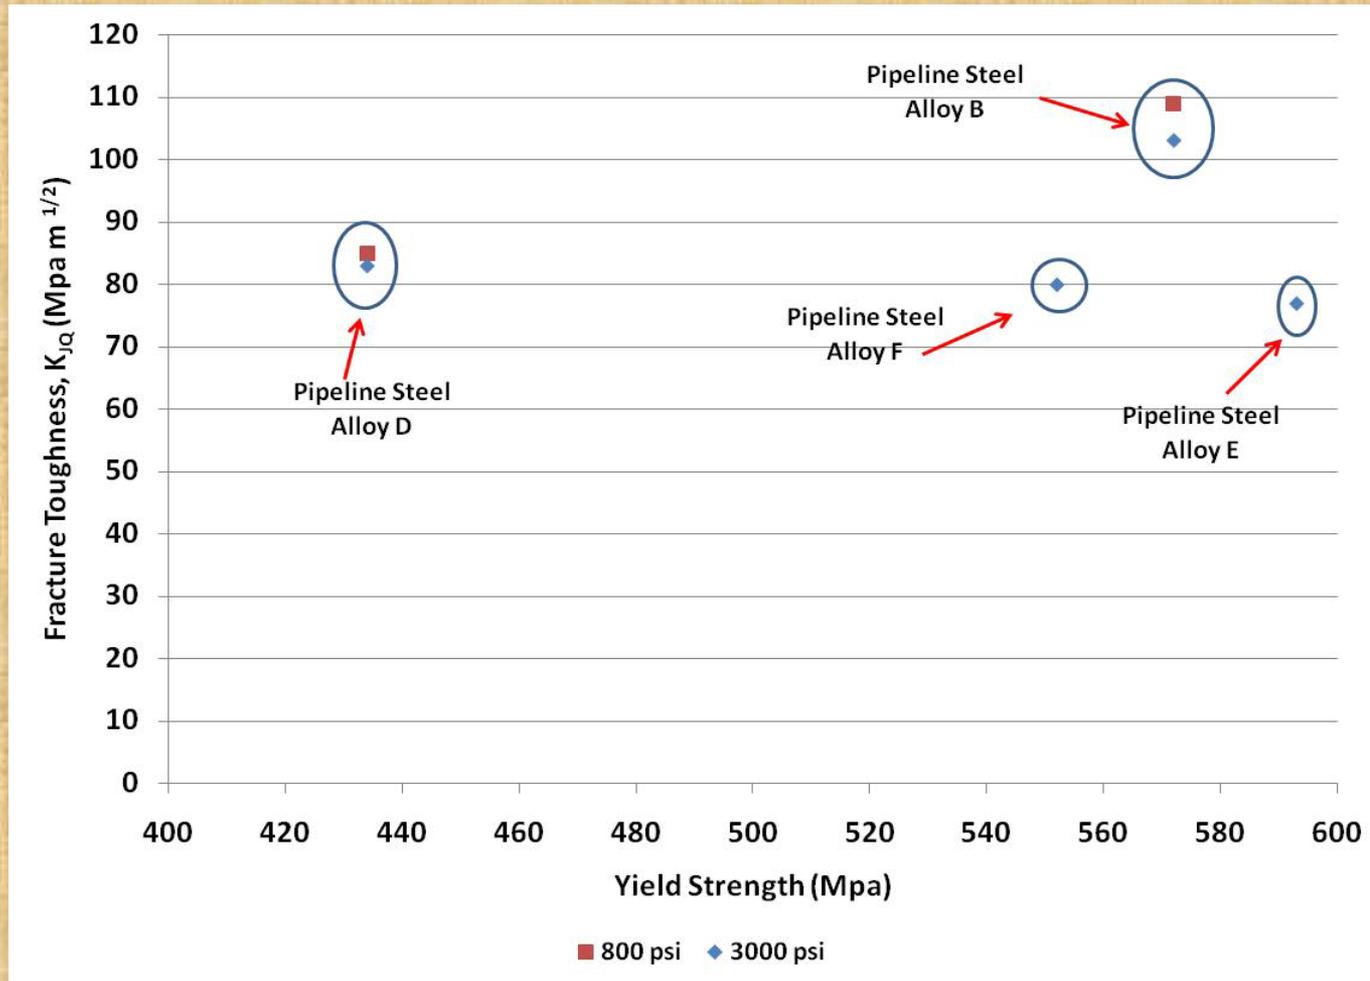
Technical Accomplishments - Fracture Toughness Test Results – Pipeline Steel Alloy's B, D, E (Private Funded), and F (Private Funded), K_{JIC} vs. Actual Yield Strength, Average Values

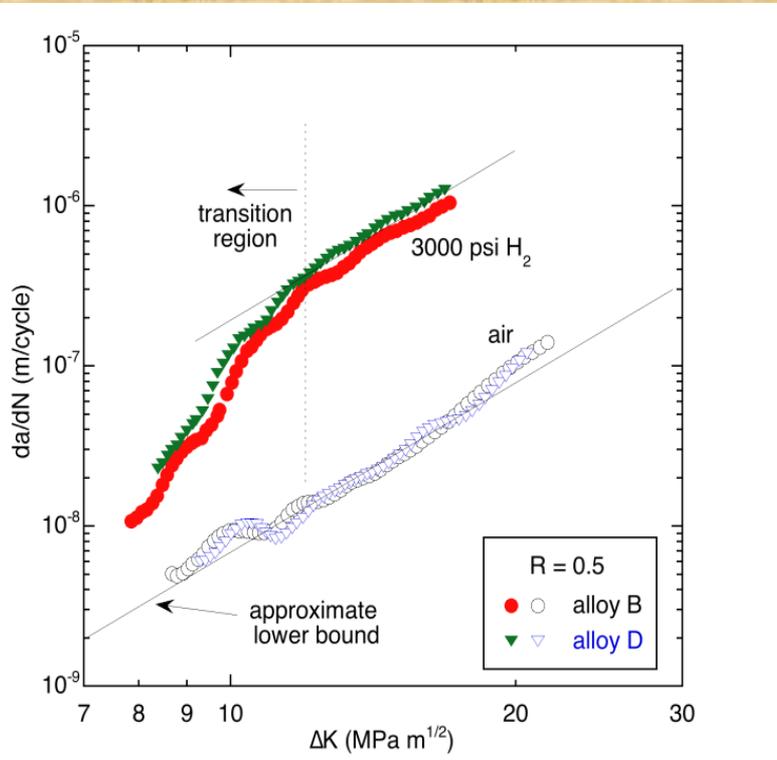
FATIGUE CRACK GROWTH OF ALLOY B AND ALLOY D IN GASEOUS HYDROGEN AT PRESSURE OF 3000 PSI, COMPARED TO FATIGUE IN AIR

- R-ratio values of 0.1 and 0.5 performed similarly in the fatigue testing for the two pipeline steel microstructures tested.
- At relatively high ΔK (>12 MPa m^{1/2}) the FCGR is about 20 times greater than air, however at lower ΔK the FCGR starts to converge for both air and H₂.

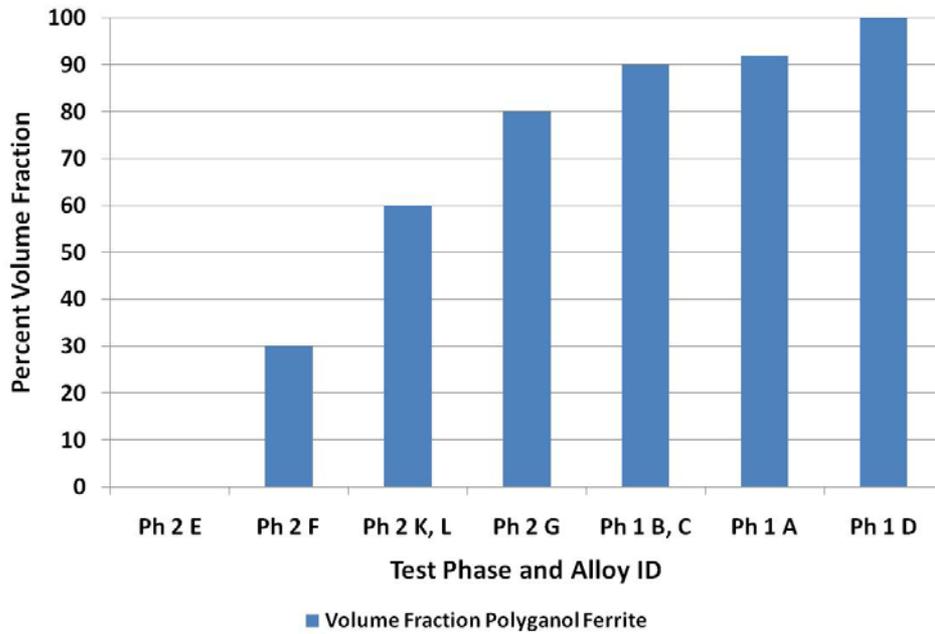
Illustration of Microstructure Testing in Phase 1 (DOE Funded)/Phase 2 (DOT/Private Sector Funded)

Volume Fraction Polyganol Ferrite

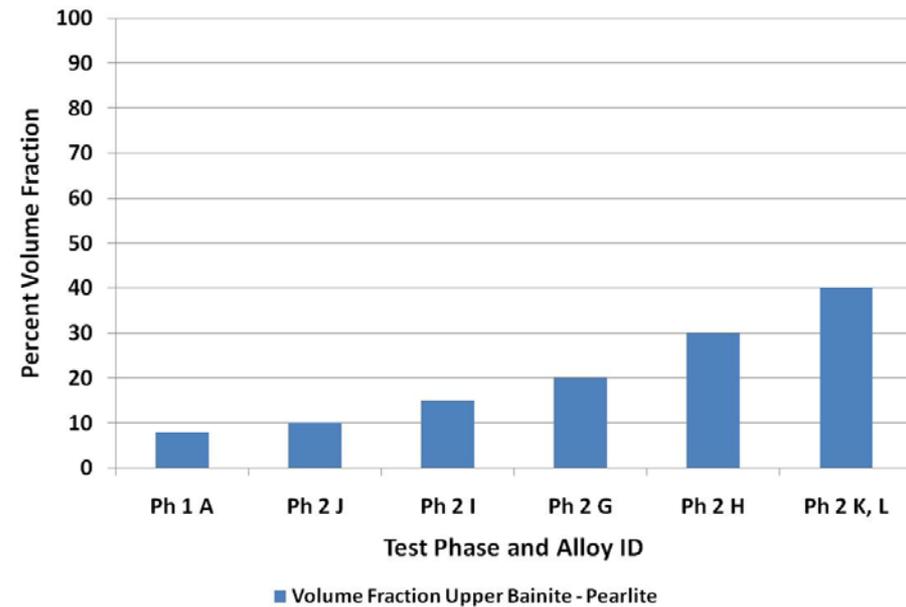
Volume Fraction Upper Bainite - Pearlite

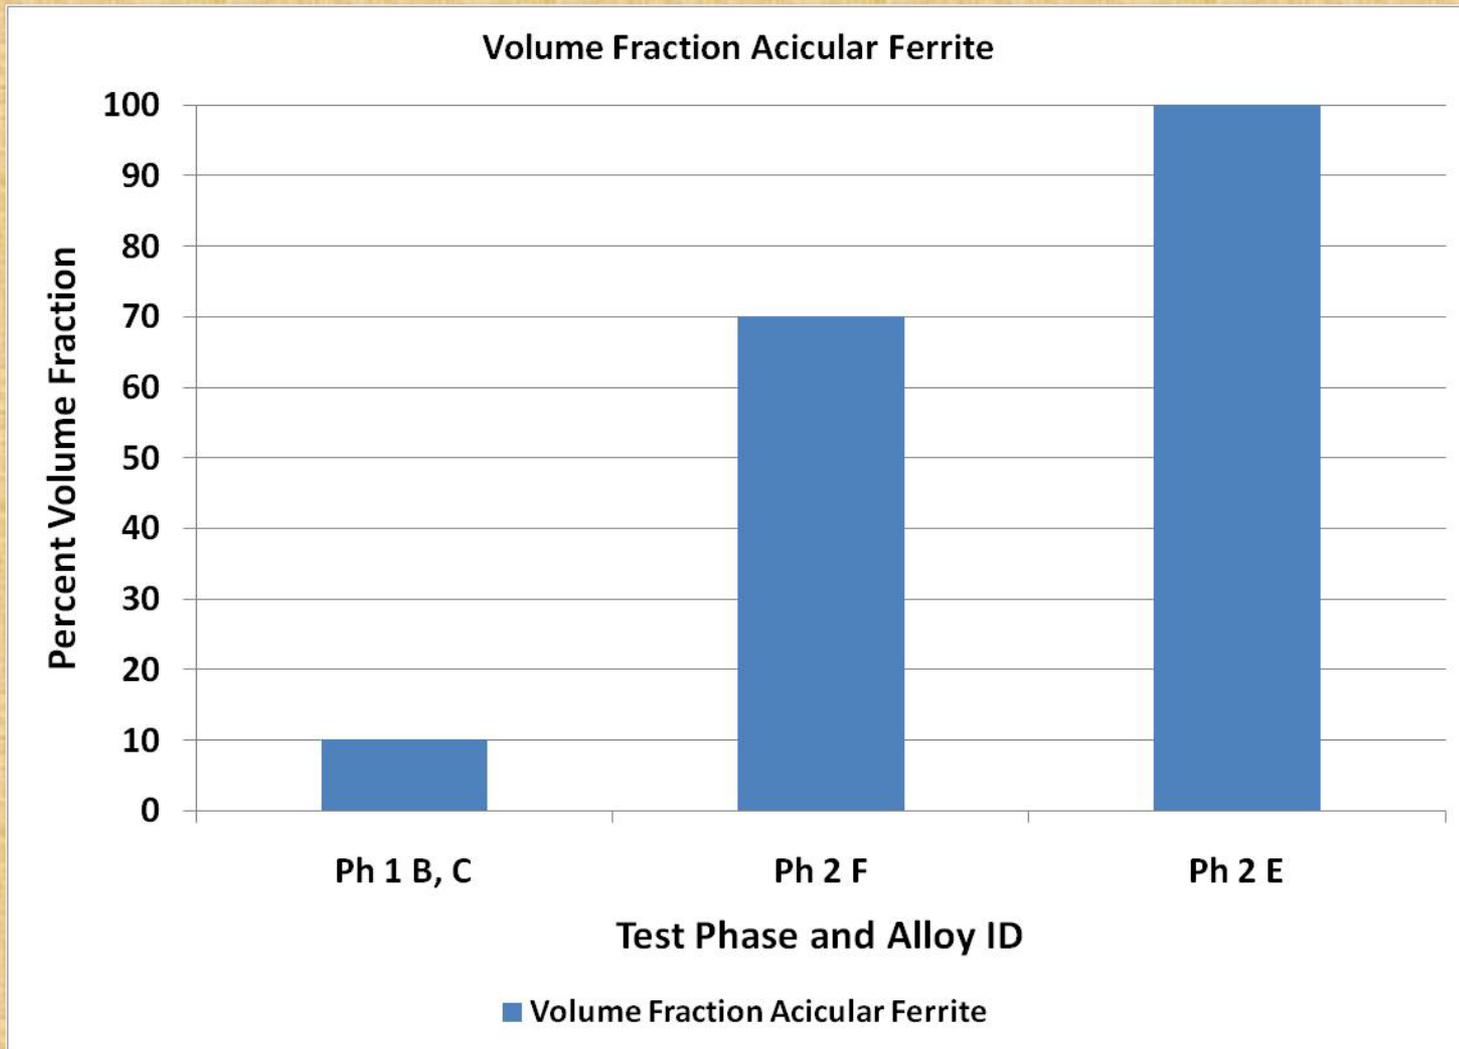
Illustration of Microstructure Testing in Phase 1 (DOE Funded)/Phase 2 (DOT/Private Sector Funded)
