Fiber Reinforced Composite Pipelines

George Rawls (PI) and Thad Adams

Savannah River National Laboratory

May 15, 2013

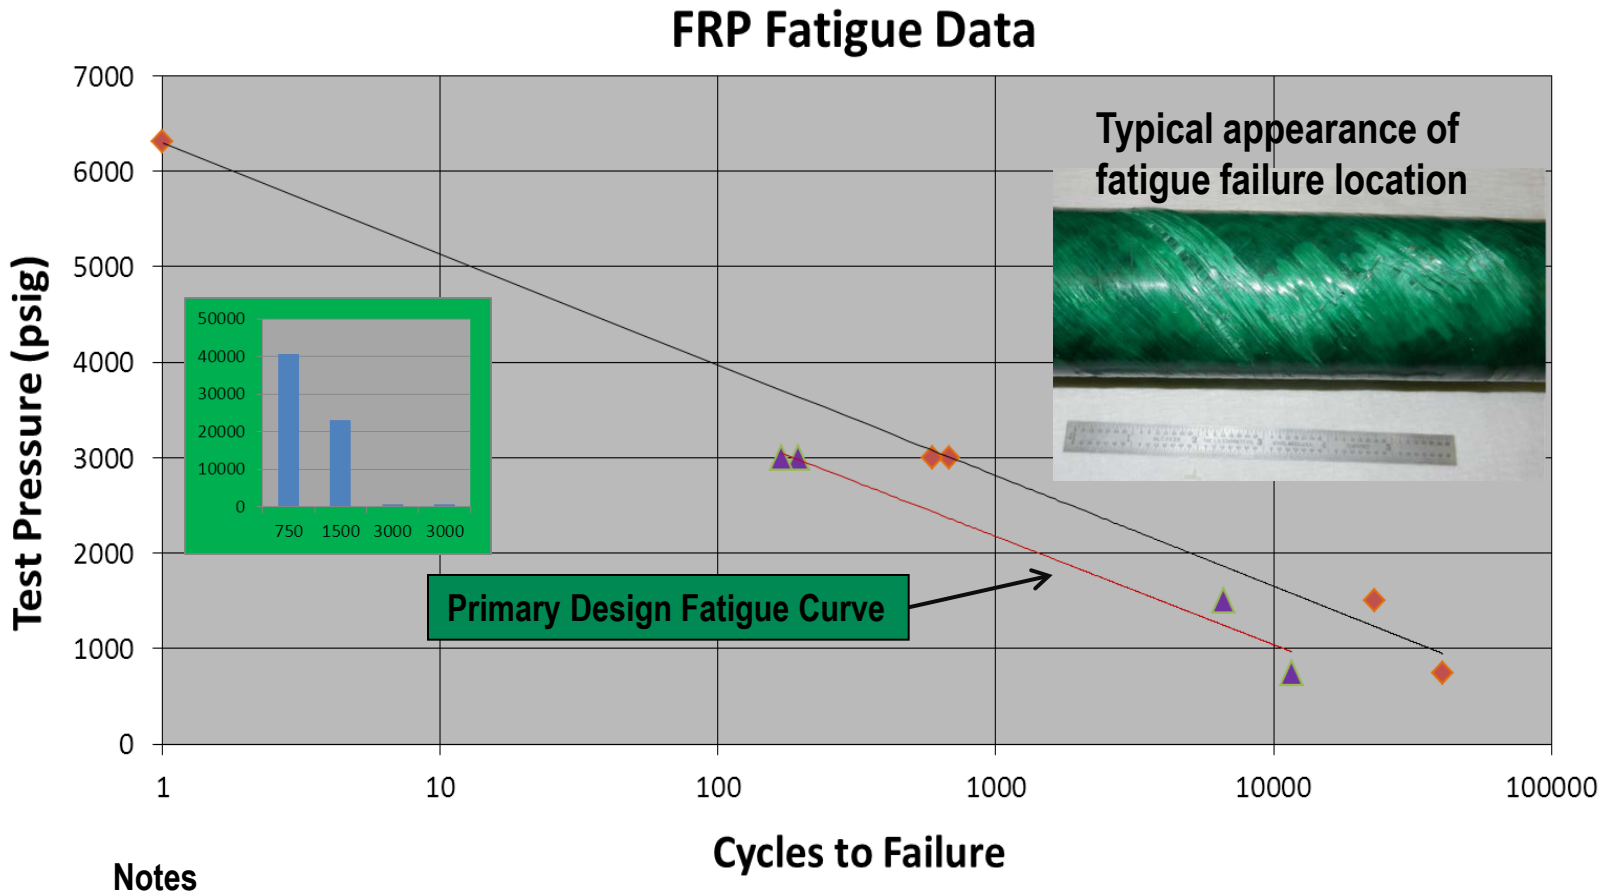
- **1500 PSI Fatigue Test -**The first test was performed at the rated pressure of the FRP product of 1500 psi. During the test a seal failure of the mechanical connection was observed at 14424 cycles. The O-ring seals were replaced and the test continued. The 1500 psi test sample has been cycled to 20,127 cycles where a structural failure of the pressure boundary occurred.

- **3000 PSI Fatigue Test –** Two fatigue test was performed at 3000 psi which is twice the product rated pressure. During the first 3000 psi test seal failures occurred at 447 cycles followed by a structural failure of the pressure boundary at 593 cycles. A second 3000 psi fatigue test failed in the pressure boundary at 681 cycles. Inspection showed damage to the O-ring at completion of the second 3000 psi fatigue test , but no seal failure occurred.

- **750 PSI Fatigue Test -** A fatigue test was performed at 750 psi which is half the products rated pressure. The test sample has been cycled to 40,000 cycles without a structural failure where the test was terminated. A seal failure damage was observed at 23,071 cycles. The O-rings were replaced and the test was completed. The damage was less severe then in the 1500 and 3000 psi tests.

1 Single cycle test represents burst test data

2 750 psig fatigue test was terminated at 40,700 cycles without a structural failure

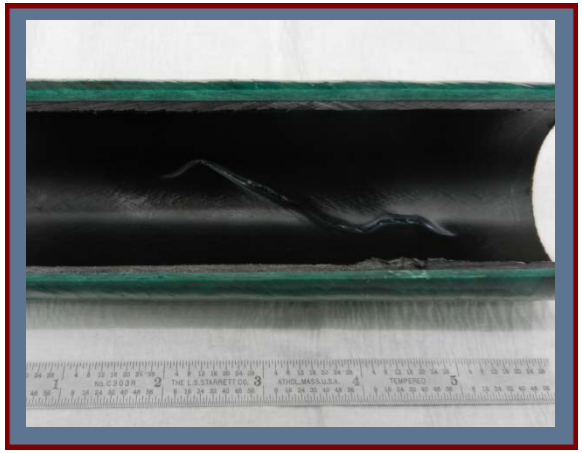
- A 3000 psig test specimen was sectioned and photographed. The internal view shows an approximately 3 inch long crack
- The magnified view through the cross-section show delamination and fiber breakage

Inside View Showing Rupture of Liner

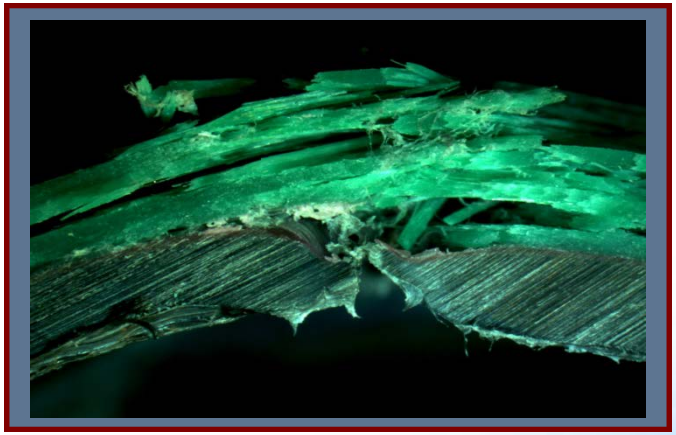
Cross-Section View Through Crack

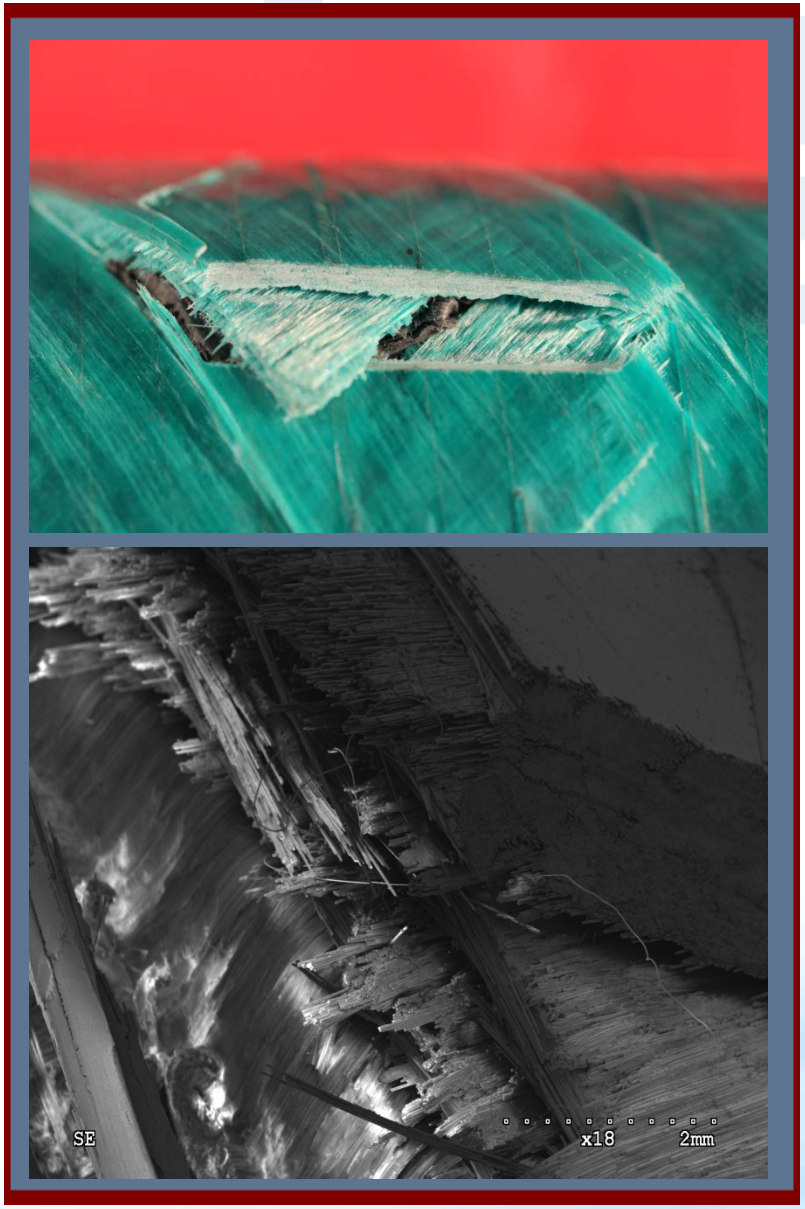
- Fatigue Tests have been performed on 2 flawed FRP samples (These test were completed in FY 12)
- The baseline flaw (1” x 0.125”) a 40 % depth was tested.
- The 2 flawed samples failed after 2830 and 4862 full design pressure cycles
- The failure mode showed that the delamination of the FRP stated to occurred at the bottom of the flaw and continued through thickness until failure occurred
- This data will be used to provide design and inspection information for ASME Codification

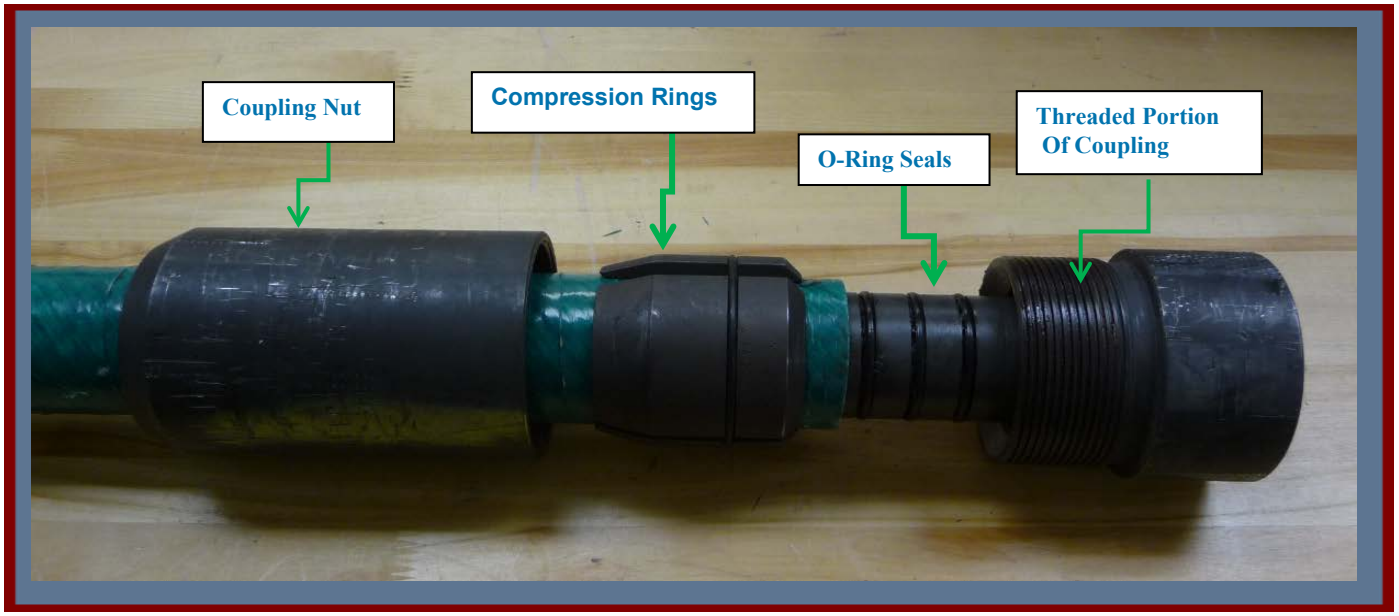
FRP Connectors -The connectors are all metallic with elastomer O-ring seals. To form the connection the internal diameter of the polyethylene liner is machined to a specified diameter. The machined portion of the liner is where the O-rings in the metallic connector interface with the composite piping to form the fluid seal. The outer nut of the connector is tightened, mechanically compressing ferrules on the piping, resulting in compression of the seals

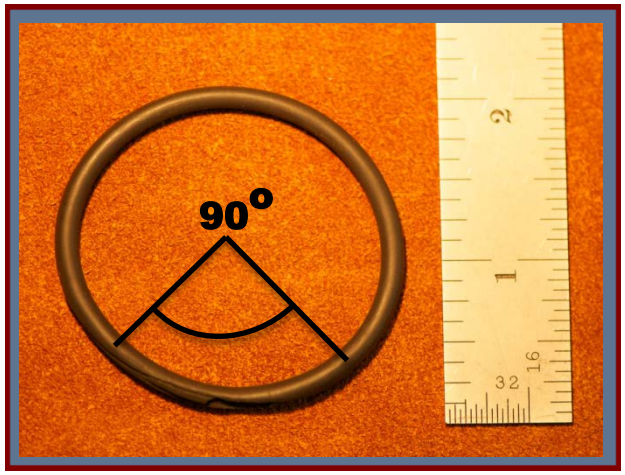
- O-ring failures occurred during the fatigue testing of the structural layer at all pressure levels
- The O-ring failures show classic indication of extrusion from their retaining grove
- The failure is a progressive distortion of the O-ring from the fatigue loading. The O-rings did not leak while testing with hydrogen or during burst testing

O-ring Damage 750 psig Fatigue Test

- **Resolution of O-ring Failures**
  - **The failure is a progressive distortion of the O-ring from the fatigue loading**
  - **Testing of the O- ring material showed that the material hardness (durometer level) was lower than the specified design value. Tested values showed that the rubber hardness was in approximately 60 Durometer M. Where values of 70 to 90 would be required based on literature data**

- **The use of a back up ring to limit the deformation of the O-ring is another common solution.**
- **This data will be used to provide design and inspection information for ASME Codification**

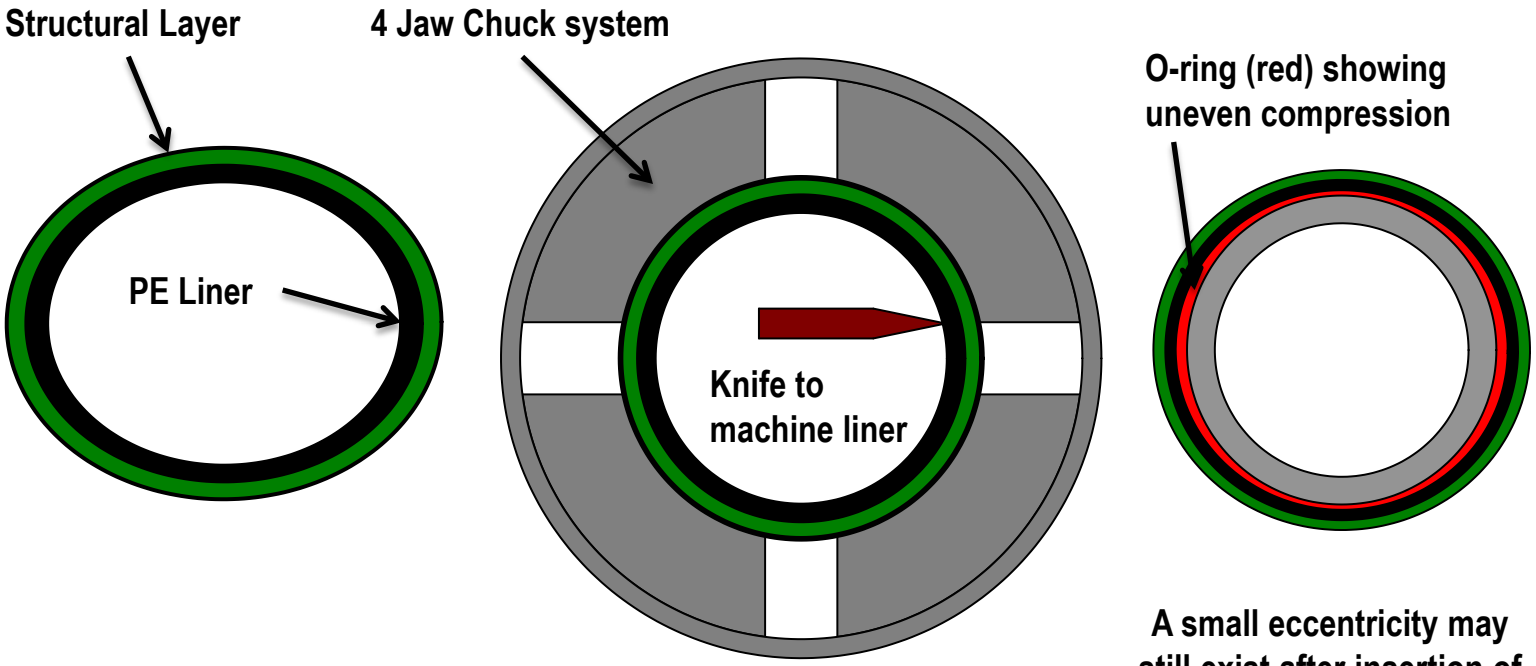
Illustration of Variation in O-Ring Compression

FRP Cross-Section Initially has a slight oval shape

A 4 jaw chuck system is used bring FRP concentric where liner is machined to coupling diameter

A small eccentricity may still exist after insertion of coupling resulting in uneven O-ring compression and partial extrusion

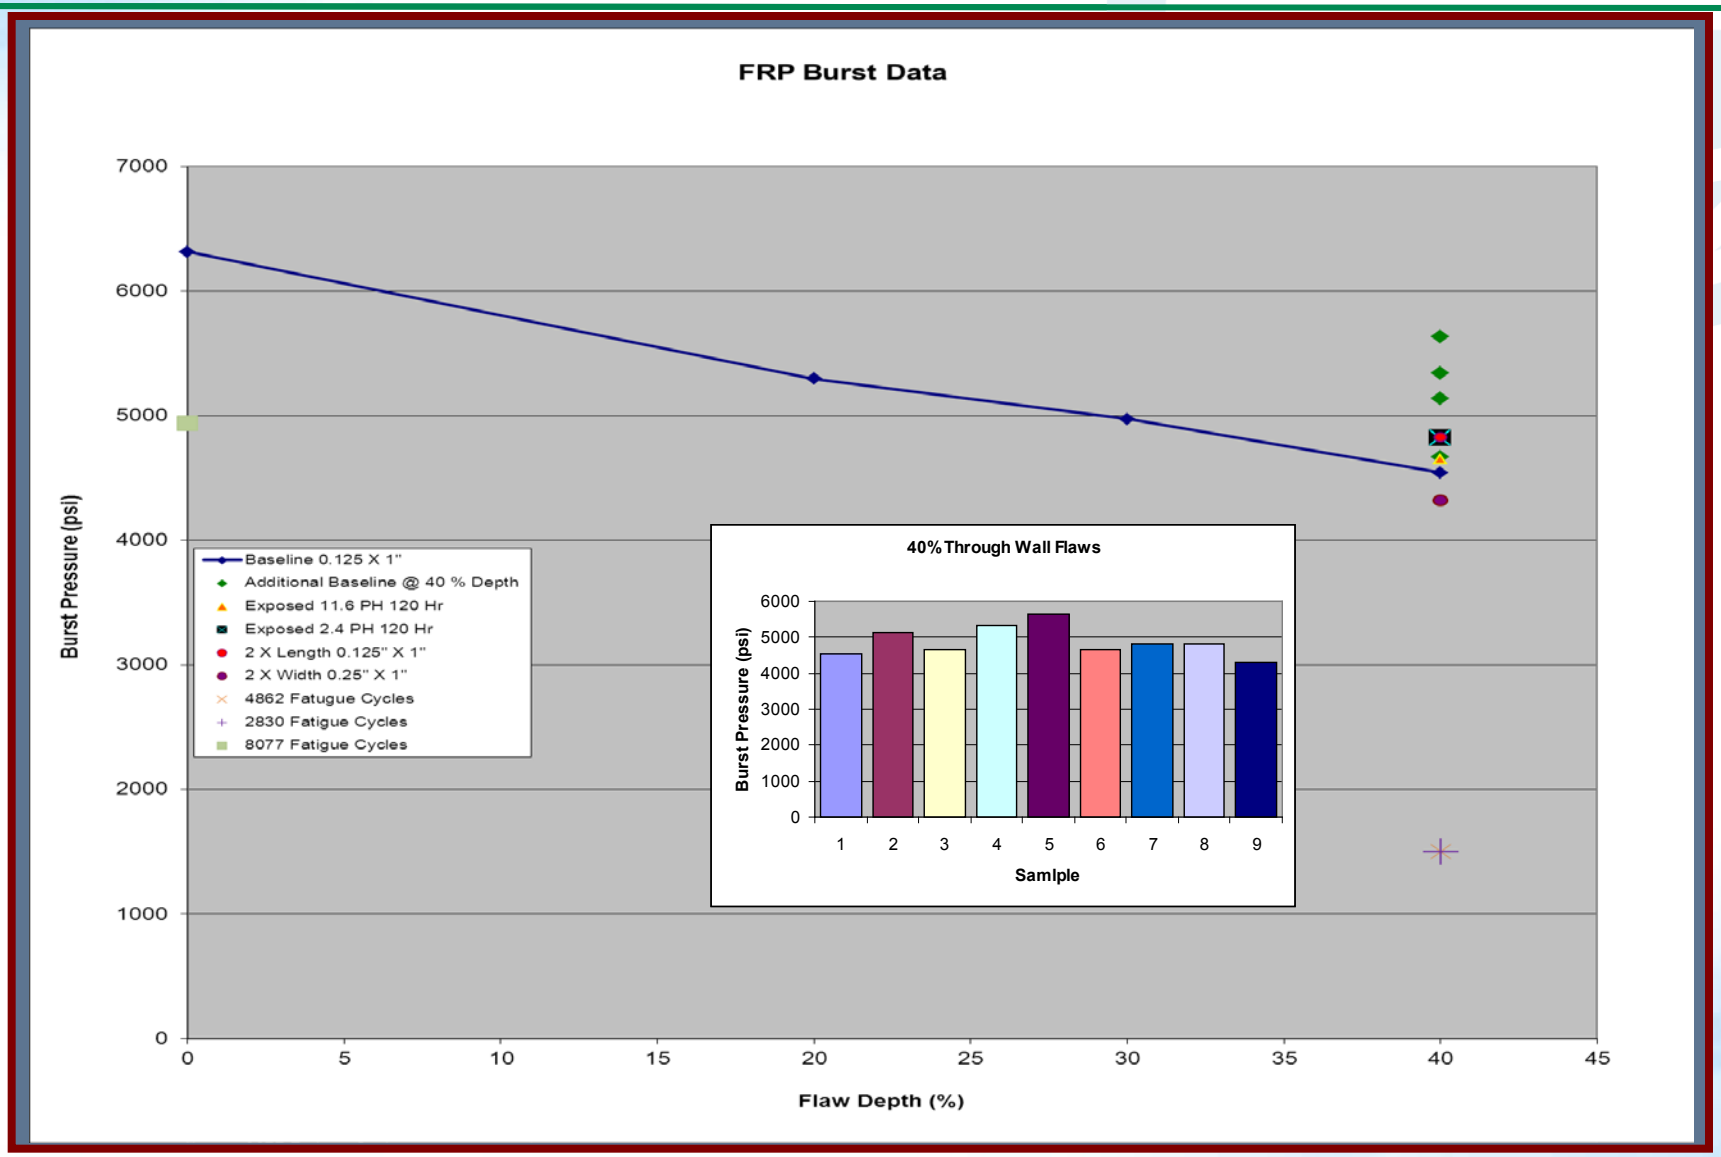
Fiber Reinforced Composite Pipeline Test Data

- Reduction in Burst Pressure from unflawed condition to 40% through wall flaw of 28 % for short term burst and multiple layer reinforcement
- With the 40 % through wall flaw there is still a margin of approximately 3 above the rated pressure

Failure mode changes from global to local and then move back towards global as flaw depth increases

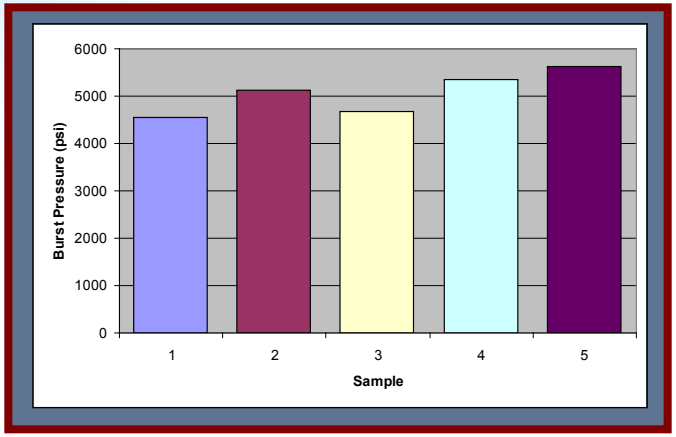
Additional Baseline Flaw

1”x 0.125”

40% Depth

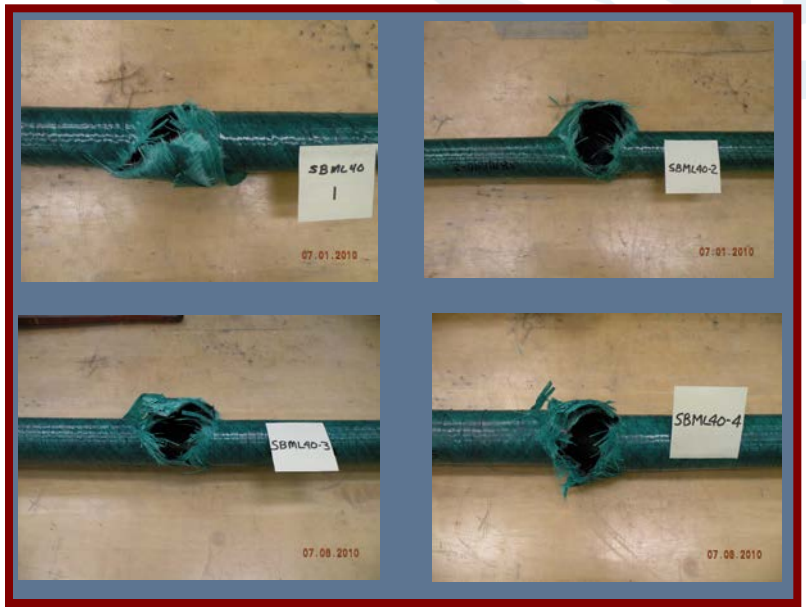
Baseline Flaw

1”x 0.125”

40% Depth

No Evidence of Bulging Under Sustained Pressure

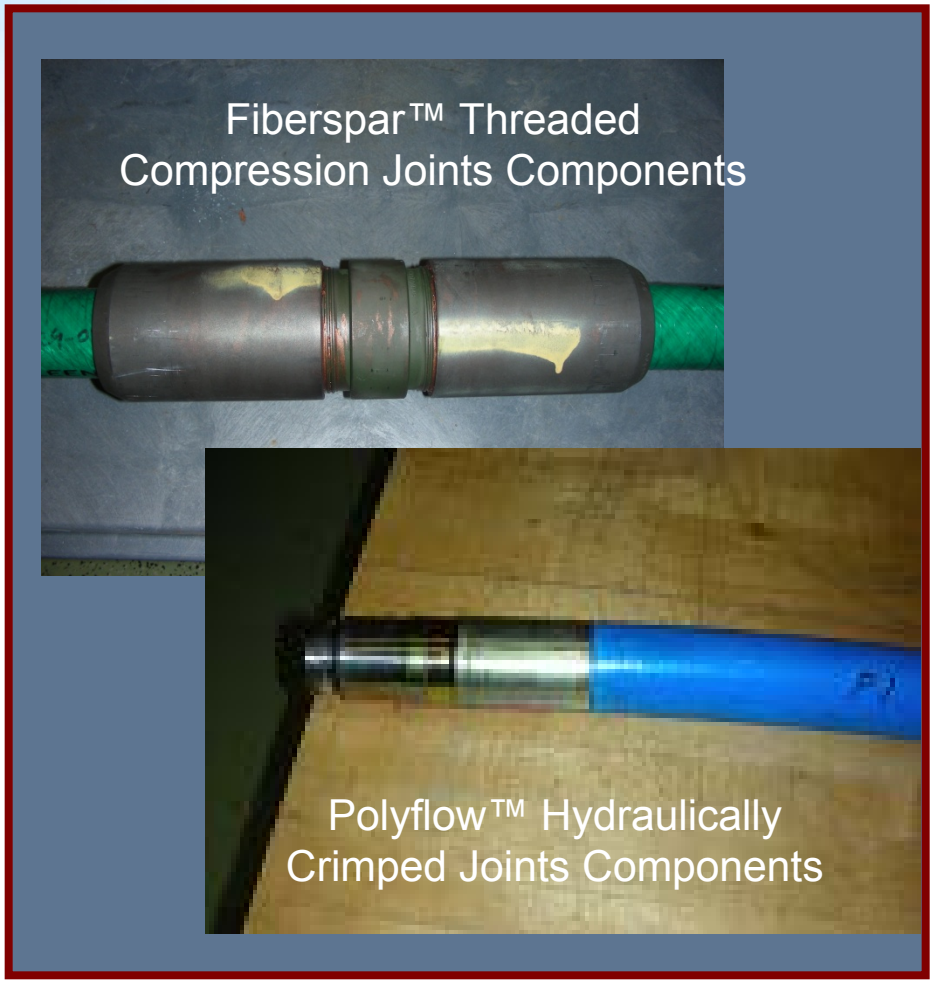
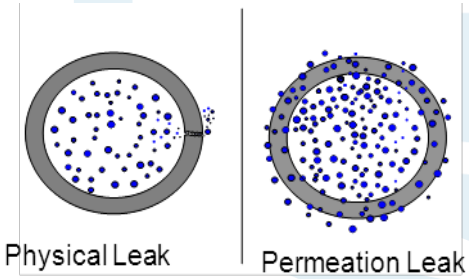
Fiber Reinforced Composite Pipeline Leak Testing

- **NASA Report NSS- 1740.16 Pressure boundary rupture only make up 14 percent of the hydrogen accidents. Accidents due to leakage and improper handling of hydrogen make up a greater percentage of the accidents**

Sample	Leak Rate STD CC H_2/Sec
Fiber 1	9.8×10^{-5}
Poly 1	9.5×10^{-3}
Poly 1+	5.0×10^{-2}

Standard Code Leak Testing Evaluates Leak Rates on the Order of 10^{-2}-10^{-4}cc/sec of the fluid
